Certificate of Conformance for Freight Container Mechanical Seal Testing
Seal Classification: High Security Seal

試驗報告 TEST REPORT

Test Report No. : N0906028-T01

SUBJECT : Freight containers Mechanical seals classification Testing

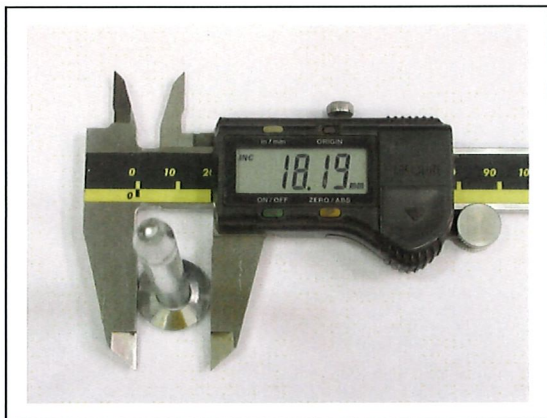
Specimen No.	Measurement (mm)		Pass/Fail
26	Pin Head	18.19	Pass
	Lock Body	18.21	Pass

The minimum diameter (or minimum widest cross-dimension) for the metal components of a bolt seal shall be 18 mm.

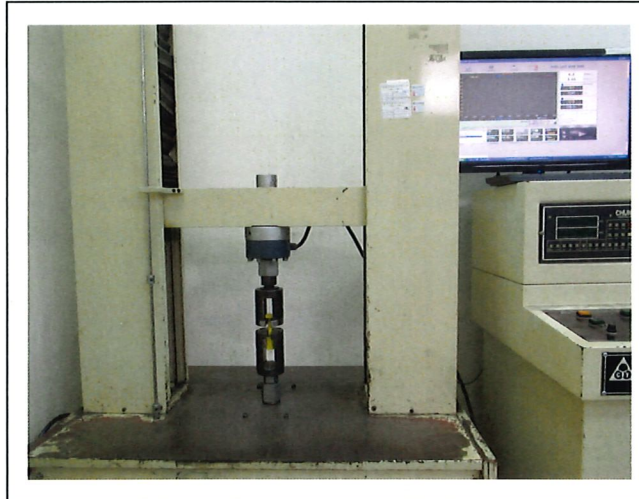
Testing Instrument : Universal Testing Machine (No.TG0103)

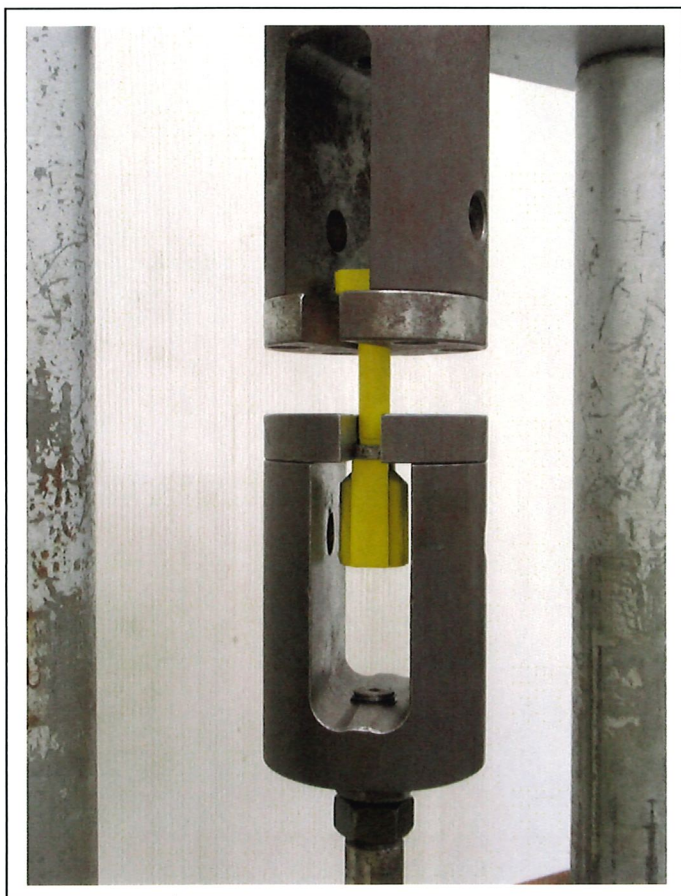
Impact Set up

The impact test is performed at 18 degrees C and minus 27 degrees C of temperature.

The impact load is applied at the locking mechanism of the seal in the direction opposite the direction used in locking the seal.

Impact Test at 18±3°C					
Specimen No.	Requirement	Result Joule			Seal classification
		13.56	27.12	40.68	
16	40.68J : High security seal 27.12J : Security seal <27.12J : Indicative seal 5 impacts at each load	Pass	Pass	Pass	High security seal (H)
17		Pass	Pass	Pass	High security seal (H)
18		Pass	Pass	Pass	High security seal (H)
19		Pass	Pass	Pass	High security seal (H)
20		Pass	Pass	Pass	High security seal (H)

Impact Test at -27±3°C					
Specimen No.	Requirement	Result Joule			Seal classification
		13.56	27.12	40.68	
21	40.68J : High security seal 27.12J : Security seal <27.12J : Indicative seal 5 impacts at each load	Pass	Pass	Pass	High security seal (H)
22		Pass	Pass	Pass	High security seal (H)
23		Pass	Pass	Pass	High security seal (H)
24		Pass	Pass	Pass	High security seal (H)
25		Pass	Pass	Pass	High security seal (H)
